# Birch Lake

# Water Quality

Updated July 18, 2018

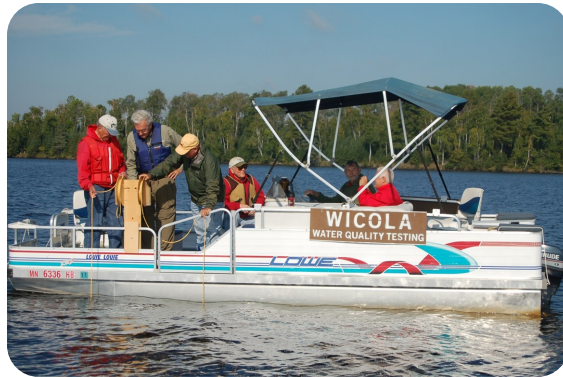
Birch Lake water quality has generally been holding steady over the seven years in which volunteers have been sampling through Citizen Lake Monitoring Plus, a program of the Minnesota Pollution Control Agency (MPCA). Volunteer measurements for Total Phosphorus, Chlorophyll-a, and Secchi depth are shown to the right for each of the three sites sampled. Total Phosphorus and Chlorophyll-a numbers are within expected ranges for lakes of the Northern Lakes and Forests (NLF) ecoregion. While Secchi depth is not, this is due to bog stained water, rather than an impairment. A slight decrease in transparency as shown by Secchi depth without a corresponding increase in Chlorophyll-a suggests a culprit other than algae. Total Phosphorus, Chlorophyll-a, and Secchi depth measurements are used to generate a Trophic State Index (TSI) number - a way of characterizing a lake's productivity. Birch Lake's mean TSI is **52**, which is slightly eutrophic:

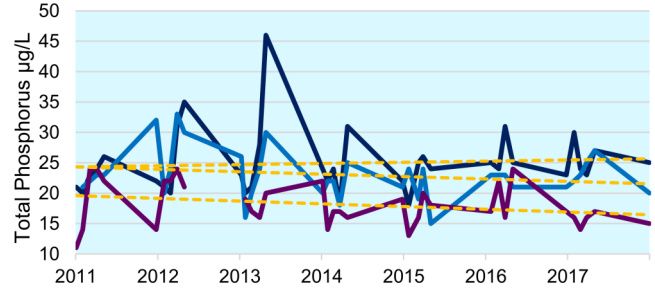
### Total Phosphorus

(NLF range 14-27 µg/L)

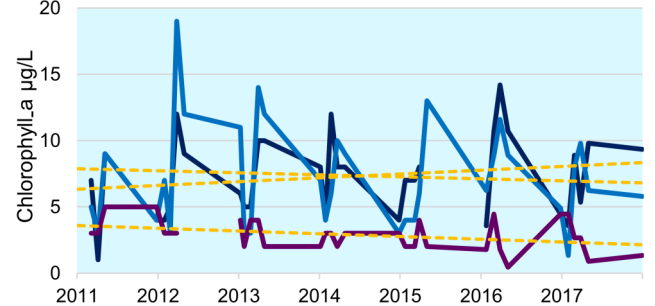
### Chlorophyll-a

(NLF range <10 µg/L)

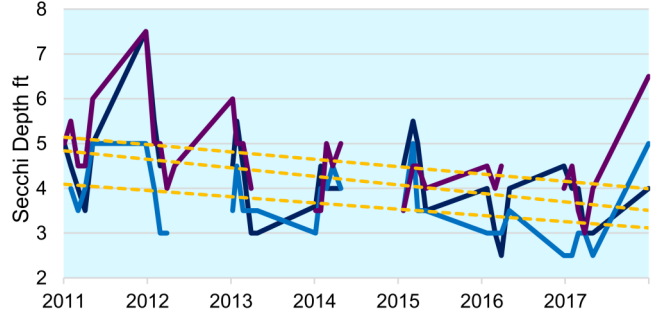
### Secchi Depth

(NLF range 8 - 15 ft)
